Miscellaneous Paper CERC-96-3
May 1996

Physical Model Study of Breakwater Stability, Kodiak, Alaska

Prepared for U.S. Army Engineer District, Alaska

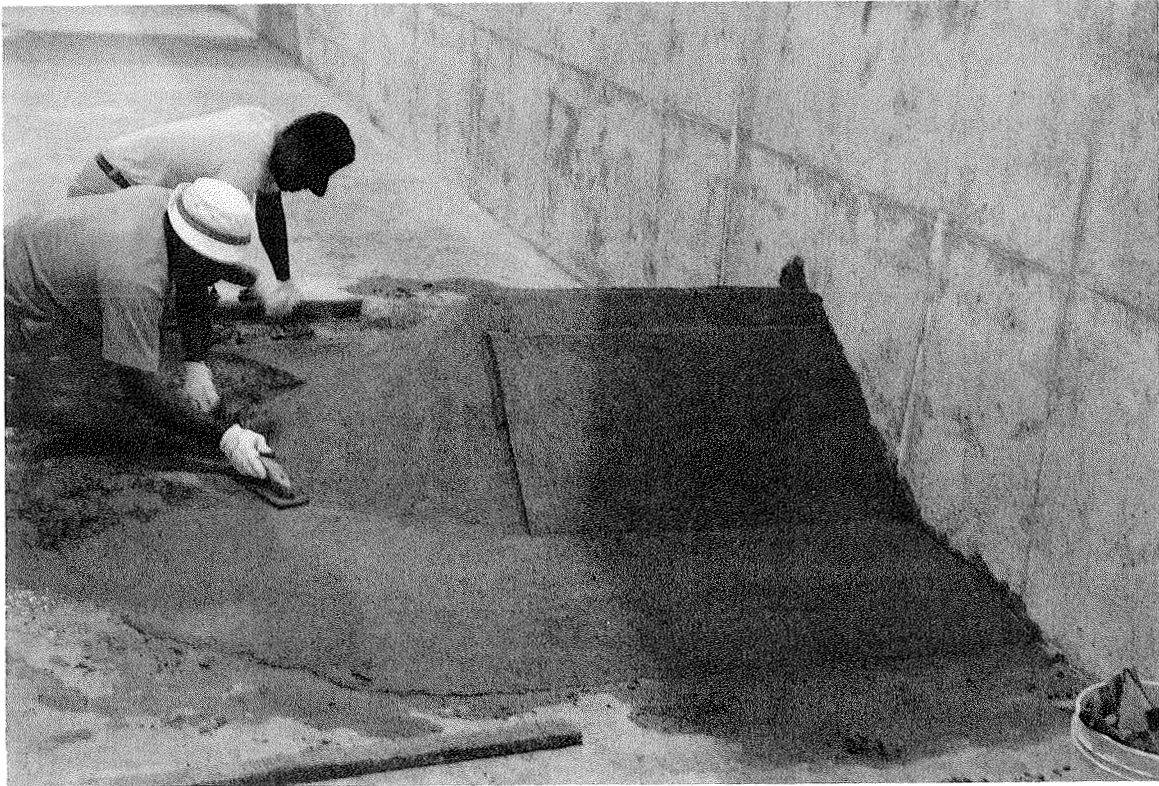
Photo 1. Construction of sand and concrete model core

To simplify construction and minimize rebuilding time, a concrete core was constructed by shaping a layer of concrete over sand (Photo 1). The concrete core was then covered with a 75-mm-thick (3-in.-thick) layer of gravel scaled to prototype material used for the consolidation pad and breakwater core (Photo 2). The 75-mm-thick (3-in.-thick) layer of gravel ensured that the breakwater would respond correctly to the core material, while the concrete core minimized sorting and rebuilding that would be required in the event of a catastrophic failure of the model. Sheet metal templates used to place the layer of gravel were removed after gravel was in place.

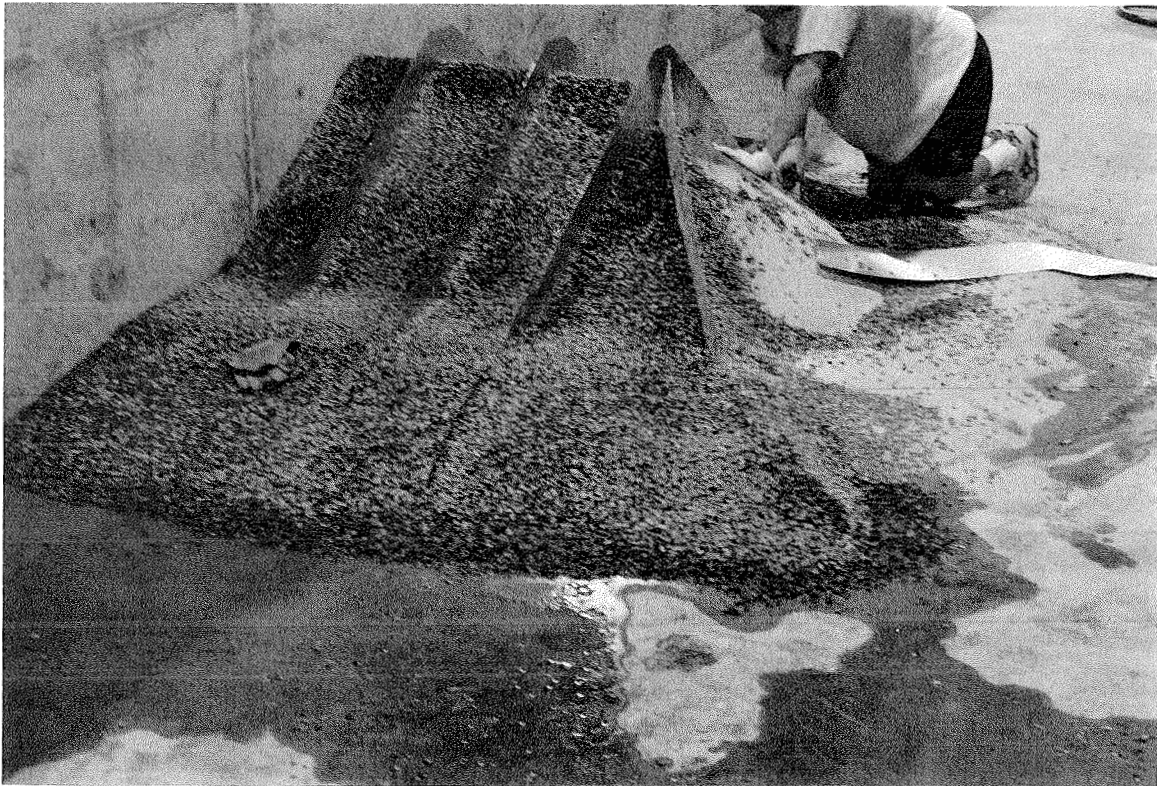
Photo 2. Placement of gravel layer over model core

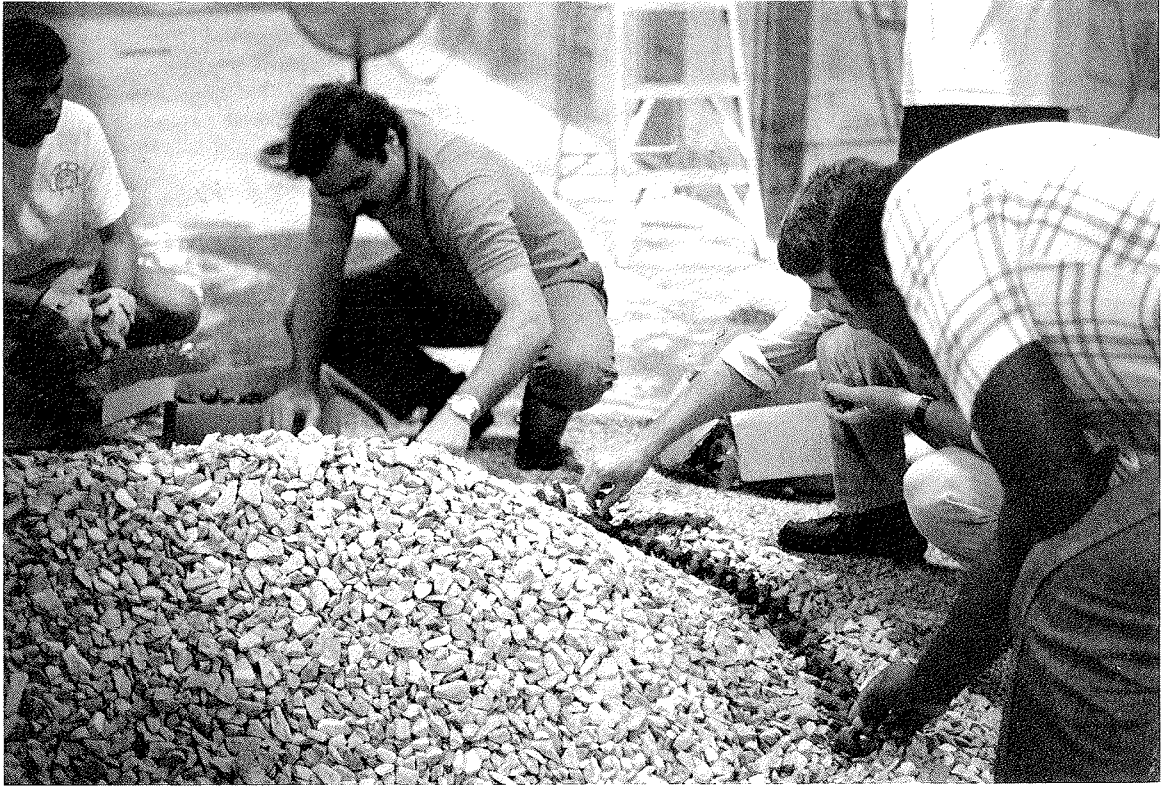
Photo 3. Placement of Core-Loc concrete armor units on model toe

Core-Locs along the toe were placed individually in a uniform pattern as shown in Photo 3. All Core-Locs placed above the toe row were randomly placed. On the harbor side, first row above B-stone also was uniformly placed as at the toe, with all subsequent rows randomly placed.

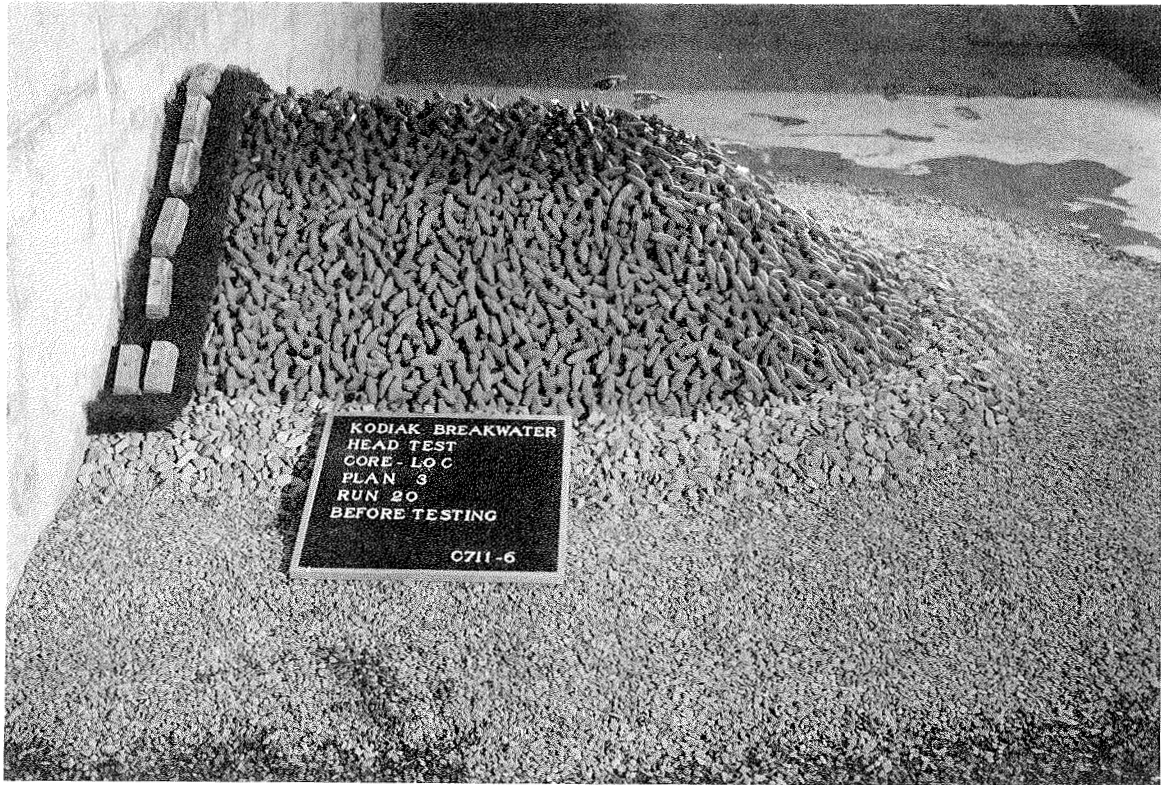
Photo 11. Sea-side view of model breakwater Plan 3 before testing

The sea-side slope and structure head were not rebuilt after Plan 2 testing. All Core-Locs were removed from the crest and harbor-side trunk, and the larger-sized B-stone on the harbor-side trunk were removed. The crest and harbor-side trunk were then rebuilt. Plan 3 used 143 more Core-Loc units than Plan 2 due to placing the Core-Locs further down from the crest on the harbor-side trunk. A strip of horsehair 0.15 m (0.5 ft) wide was placed over the structure along the wall from the sea-side toe to the harbor-side toe to protect units near the wall from wall effects. Photos 11 and 12 show the sea side and harbor side, respectively, of Plan 3 before testing.

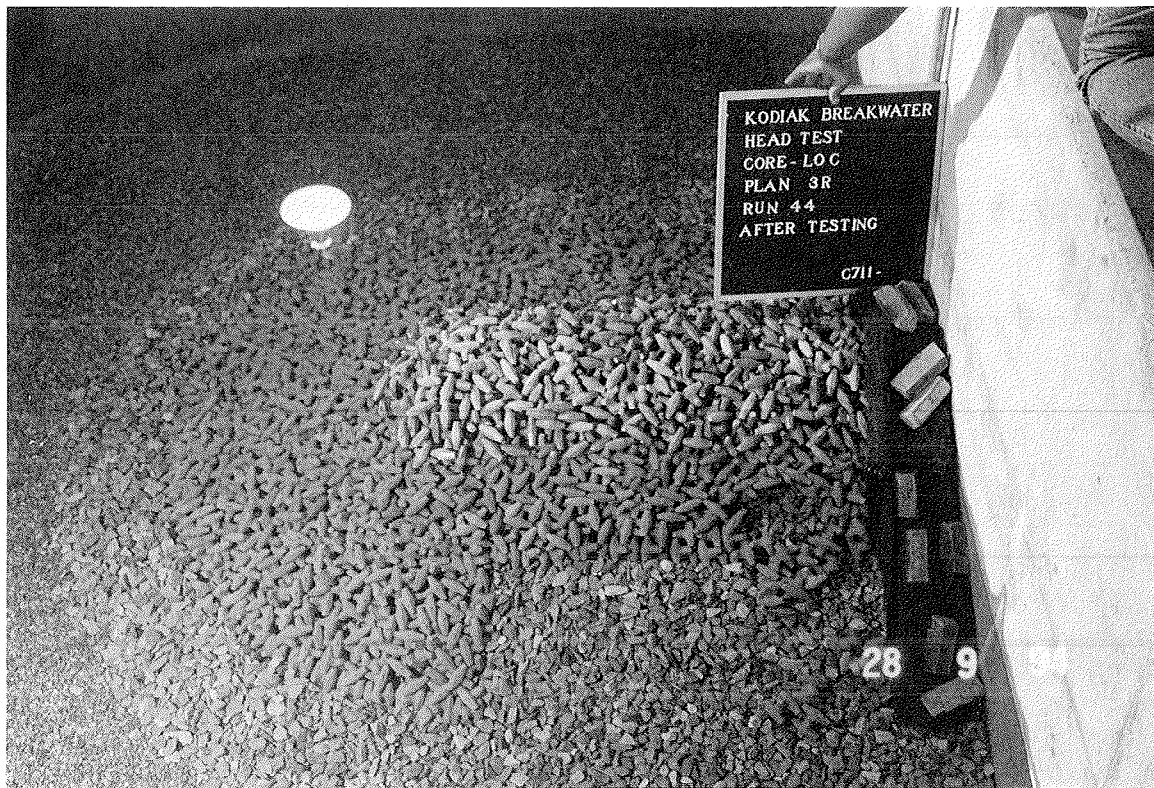
Photo 16. Damage sustained by model breakwater during demonstration runs of Plan 3R

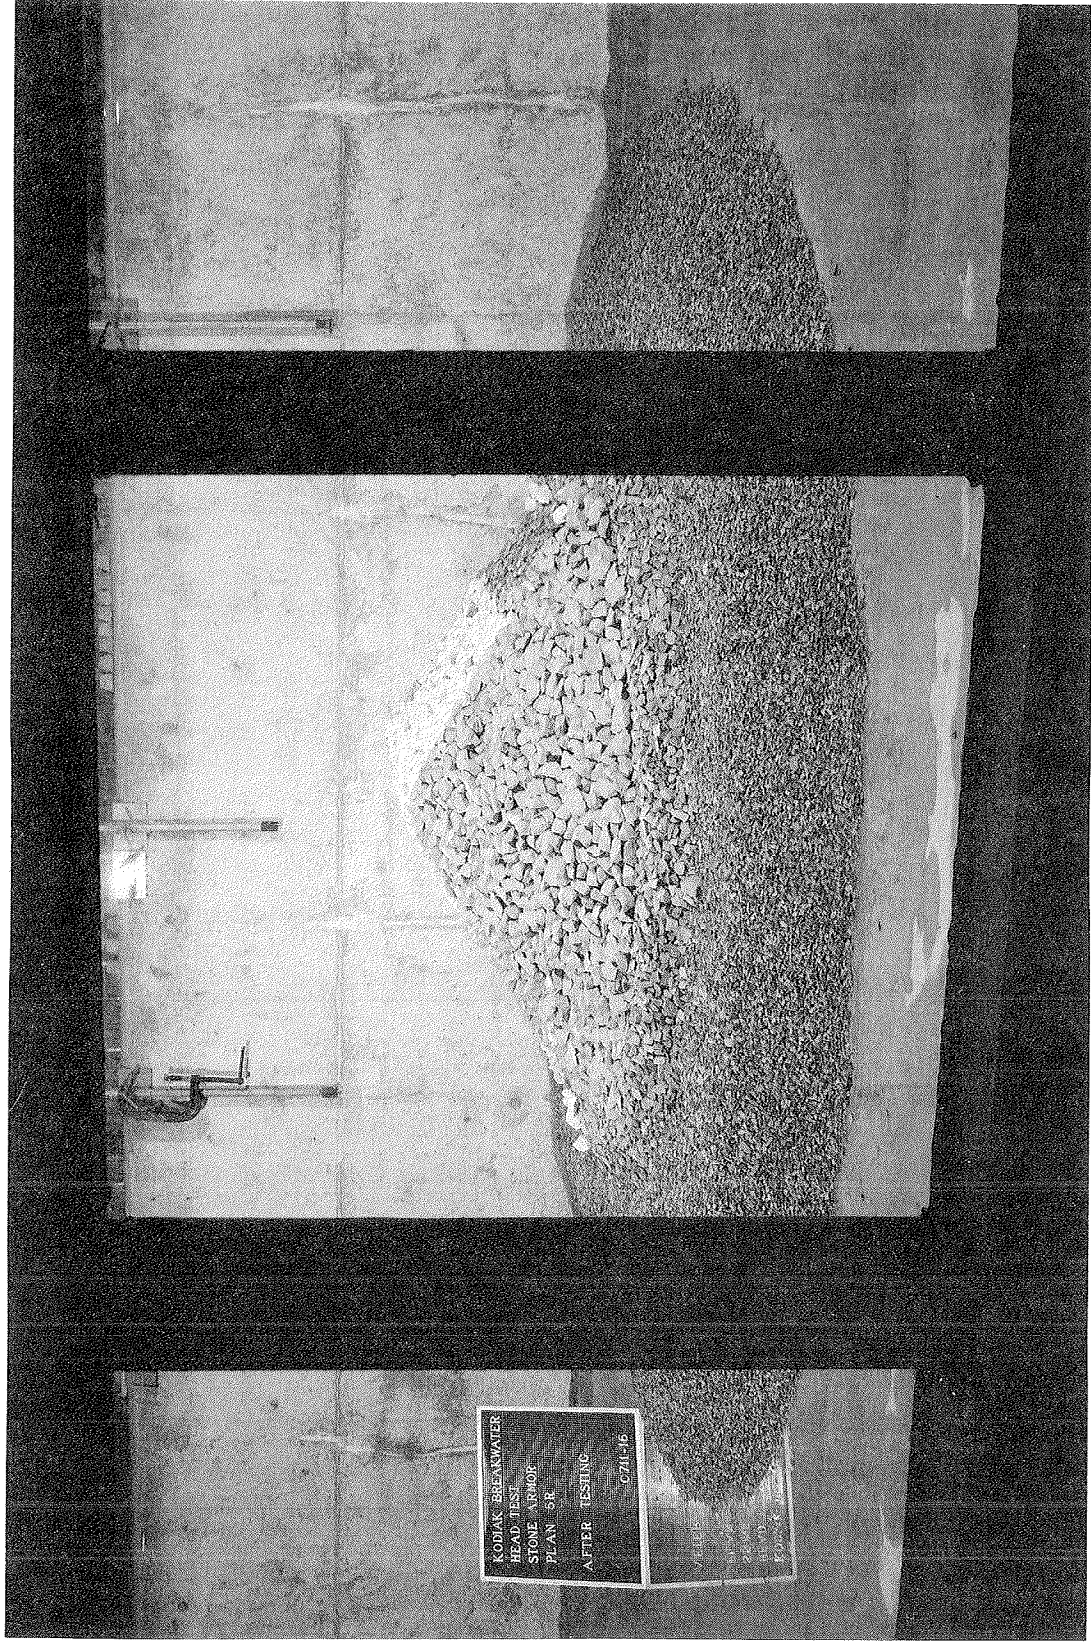
Photo 27. End view of model breakwater Plan 5R after testing

The final three test runs of the St. Herman Harbor stability test series were conducted at swl = 0.0 m (0.0 ft) mllw with $T_p = 14$ sec and $H_{m0} = 1.7$ m (5.5 ft). Each of the last three runs was of 48-min duration. Three additional stones were lost from the scour hole on the sea-side trunk with minor additional damage observed elsewhere on the structure. No damage was detected on the structure toe or consolidation pad. Photos 26, 27, and 28 show the sea side, end view, and harbor side, respectively, of Plan 5R after testing.
